Service Bulletin Maintenance of Way Equipment

Date: 05/27/2021			RRP Service Bulletin No: RRP SB367			
Title: Turnta	ble Rework					
Rating:						
	ALERT (Potential Problem)		INFORMATION (Action Is Optional)			
х	DIRECTIVE (Action Is Red	quired)		PRODUCT IMPROVEMENT (Enhance Product)		
Product Seri	es : Advanced Ti	e Plate Inserte	er			
Serial No:						
ATPI-036	933588	СР	5014-21]		
APTI-037	933588	СР	5014-22	=		
ATPI-038	933588	СР	5014-23			
APTI-032	933588	CP	7014-14			
ATPI-035	933588	CP	5014-20			
ATPI-009	935574	CN	438-61			
ATPI-010	935574	CN	438-62			
ATPI-019	935588	CN-W	438-65			
ATPI-020	935588	CN-W	438-66			
ATPI-021	945588	CN-S	438-63			
ATPI-022	945588	CN-S	438-64			
ATPI-030	935588	CN-W	438-67

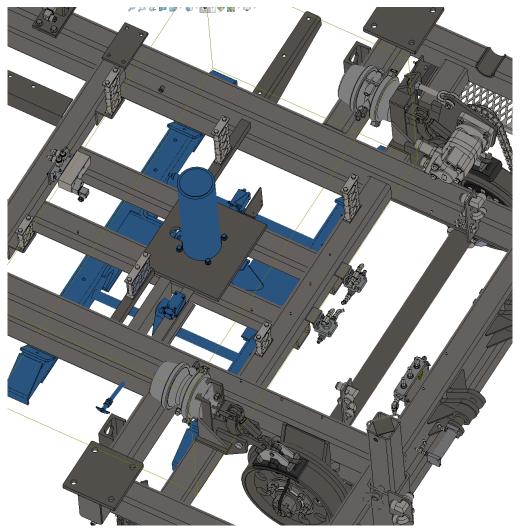
Summary: The turntable is off-centered with the machine center of gravity and can cause machine imbalance when raising the machine.

- 2. Verify the correct CG with engineering.
- 3. Remove the counterweight from the rear tube if present.
- 4. Dis-assemble the turntable and cylinder from the machine frame.

- 5. Remove related limit switches and hooks.
- 6. Cut off limit switch bracket and hook brackets.

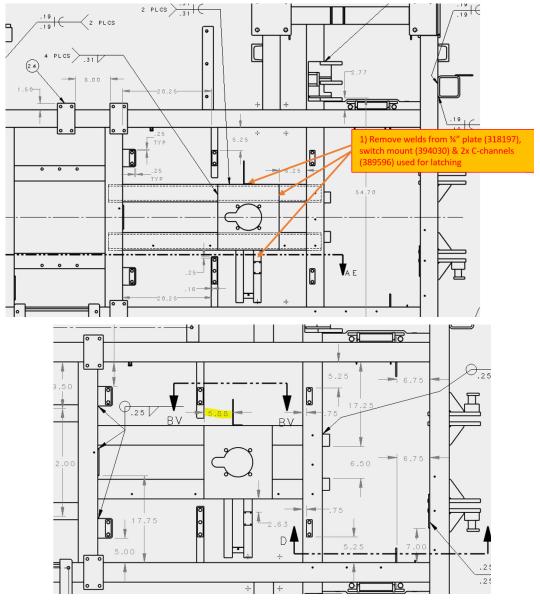
Note: Removing the weld may cause damage to existing machine place, latches, switch mount, and C-channels.

7. Remove welds from ³/₄" plate (RRP# 318197), switch mount (RRP# 394030), and 2 x C-channels (RRP# 389596) used for latching.

- 8. Cut off main turntable pad
- -Reinstall turntable pad to the new specified dimension by welding.
- -Reinstall limit switch brackets and hook brackets to new dimension by welding. New brackets may be necessary depending on their condition after removal.
