# Service Bulletin

## Maintenance of Way Equipment

**Date:** 2/10/2023**RRP Service Bulletin No:** RRP SB386**Title:** Correct a programing issue preventing John Deere equipped machines from regening.**Rating:**

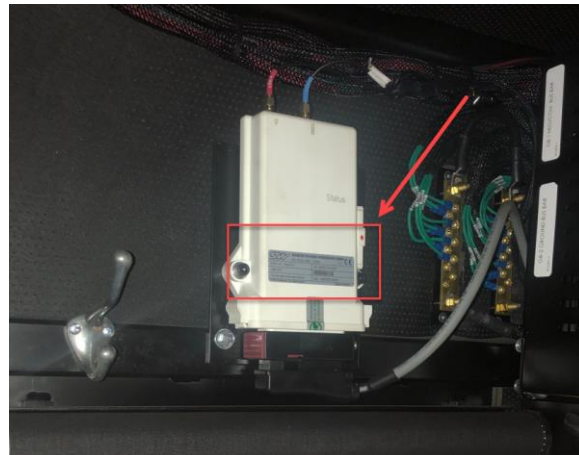
The modem is located mounted on the back of the cab.

The modem serial numbers can be found on the modem data label.
